PRE-PURCHASE PROPERTY INSPECTION

(BUILDING)
as per
AS:4349.1-2007

Visual Pre-Purchase Building Inspection Report

1.0 CLIENT DETAILS:	
Client:	[REDACTED]
Contact Details:	Ph: [REDACTED] Email: [REDACTED]
Job Invoice No:	
Report Ordered by:	Purchaser
Inspection address:	[REDACTED] Morley
Inspection Date & Time:	<u>Date:</u> 10/8/2016 <u>Arrival time:</u> 9:30 am <u>Departure time:</u> 12:10pm
Weather Conditions at time of inspection:	Damp / Cloudy
Building if Furnished:	No
Building Tenancy:	Vacant
Persons present at time of inspection:	Real Estate Agent

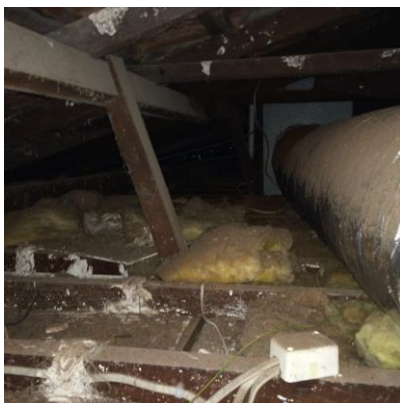
Roof Void Access Limited less than 600 mm x 600mm

(NOTE: It is recommended that an additional manhole must be put into place to gain access into the areas beyond the hindering valley are NOT crawled through at a visual pre purchase inspection)

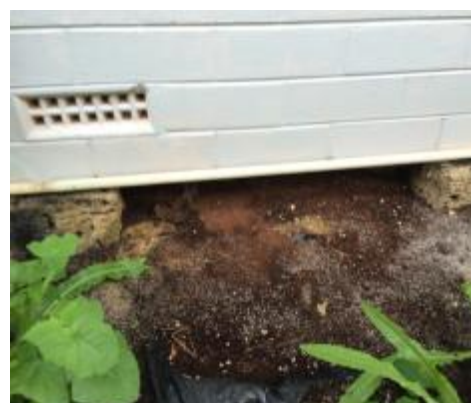
Sub Floor Access Blocked

This dwelling has had several additions which include retaining the original timber sub floor and a new concrete floor to parts of the dwelling. The sub floor had no access either internally or externally. This must be inspected to determine condition.

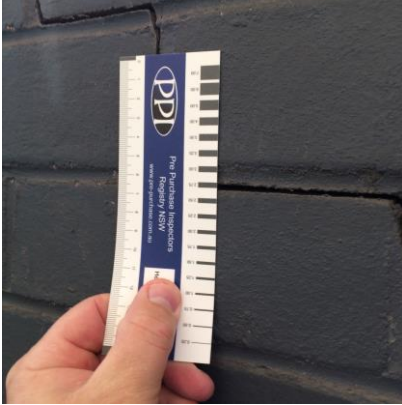
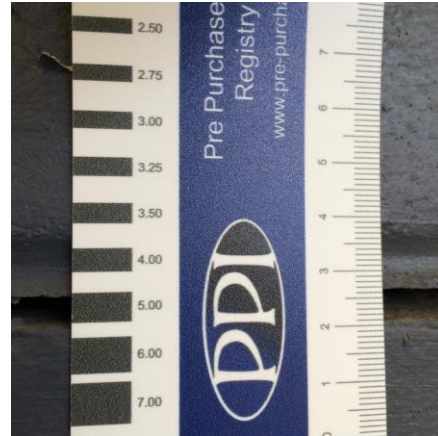
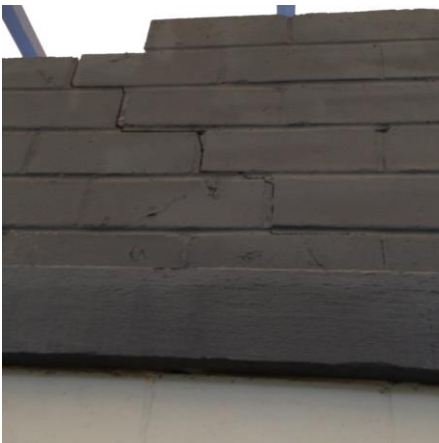
- 1/ External cracks to converted garage require rectification to avoid further damage, 'D' & 'B'
- 2/ External paving, tiling and concrete to be repaired to avoid tripping and slip hazards 'D' & 'B'
- 3/ West Nib Wall- Separated from main House- Safety Hazard 'D' & 'B'
- 4/ Safety Hazard: exhaust fan to bathroom needs to be reinstalled correctly 'E' & 'F'
- 5/ Roof flashing to be correctly installed to prevent further water ingress, 'A' & 'C' & 'D' & 'F'
- 6/ Evidence of leak to internal kitchen cupboards below sink 'A' & 'C'
- 7/ General site drainage poor and stormwater connections need to be remedied, 'C' & 'D' & 'E'

Converted garage external wall

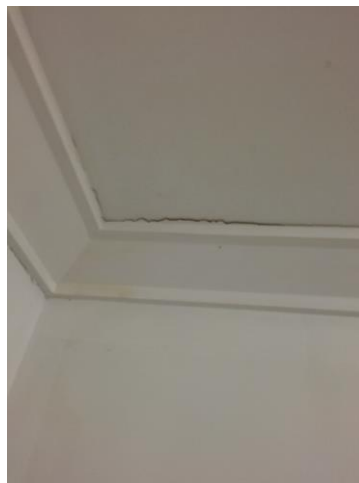
Cornice cracking

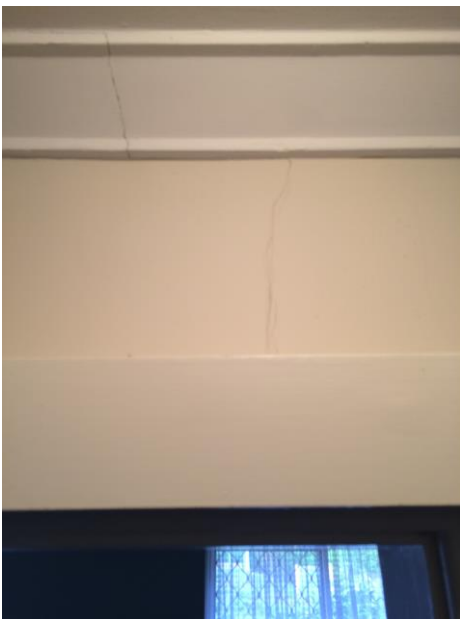
Cornice/Wall cracking

14. Wall and ceiling cracking: Wall and ceiling cracking was visibly evident in areas internally to this dwelling. *(Refer to the Cracking section of this report)*

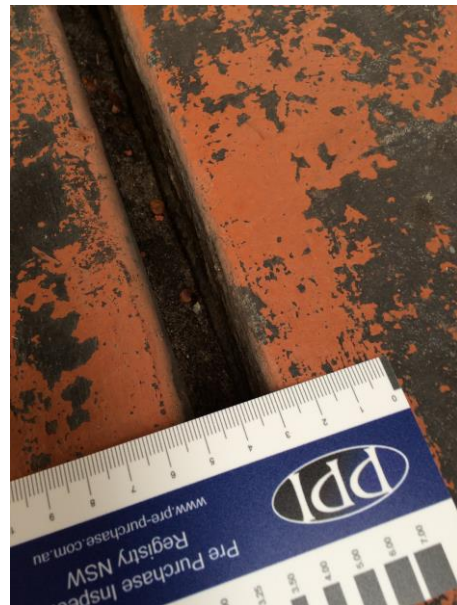
Driveway separation at control joint

5. The driveway: The front cross-over is cracked and undulated. Front kerb is cracked in areas. The concrete driveway is cracked and undulated in areas.

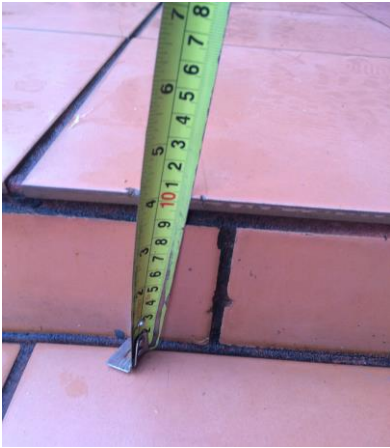
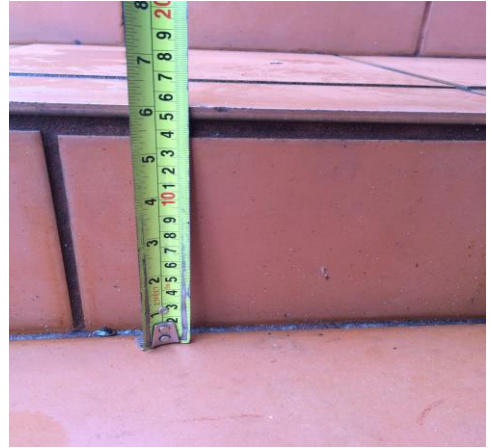
2 x Steps leading to front door have uneven risers (100mm and 150mm), this being a safety hazard

7. External exposed door locks are deteriorating to some units.
8. The front steps have uneven riser heights, this being a safety hazard. The front steps are covered with a tile that is very slippery when wet, also a safety hazard

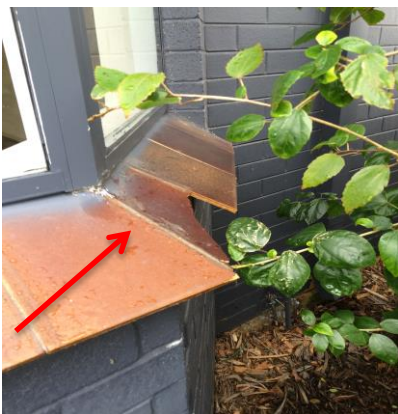
Tile cracked to front bay window

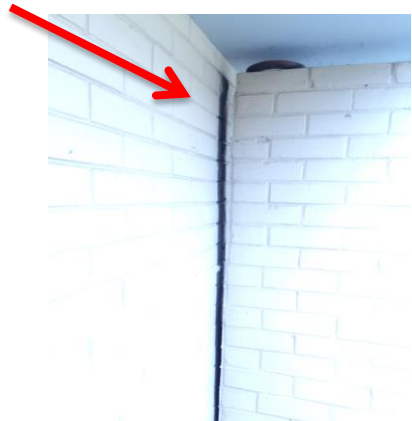
West Nib Wall- Separated from main House- Safety Hazard

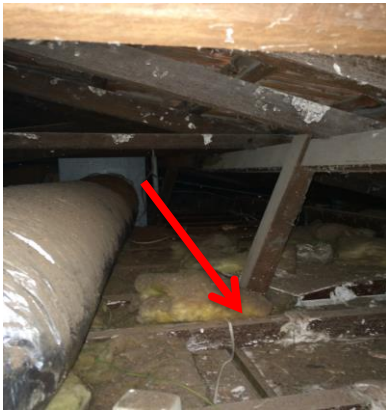
- 1/ Insulation displaced in areas, 'E' & 'F'
- 2/ Gutters and downpipes are rusting and deteriorated in areas, "C" & "D" & "E"
- 3/ Minor wall and ceiling cracking evident internally being common for the age of this dwelling, 'A' & "F"

Insulation displaced in areas

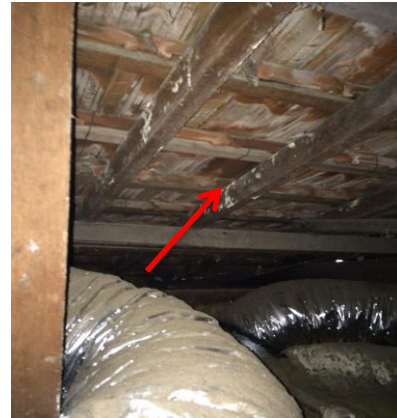
Evidence of water penetration

5. Access: Access was limited to the areas over 600mm in crawling space only
6. Roof leaking: Roof leaking was evident in areas, rectification is required.

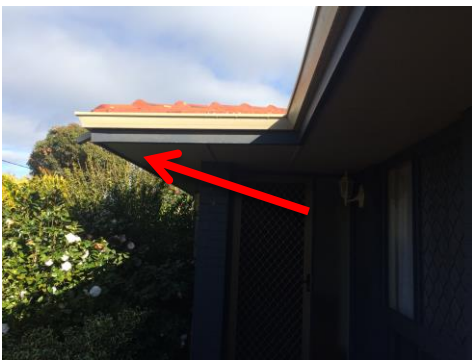
Front Hip dips to this external corner

3. Loose cables: Some loose cables will need to be correctly clipped in areas.
(NOTE: All cables in a roof loft area should not be subject to damage.)
4. Sagging or roof elements: Purlin undulation was evident, which causes visual external roof tile undulation. Front Hip (see photo) sagging to side elevation over front door

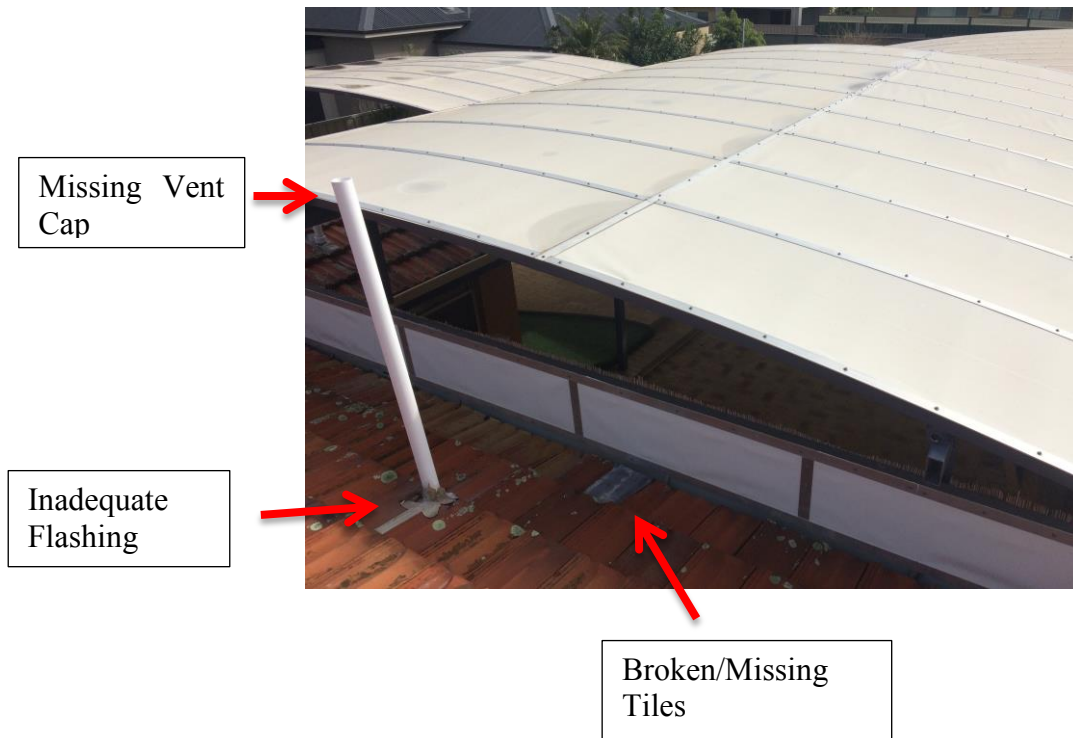
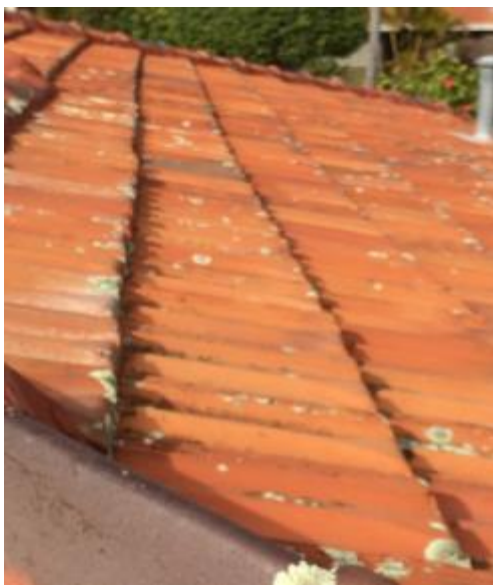
Undulating roof cover

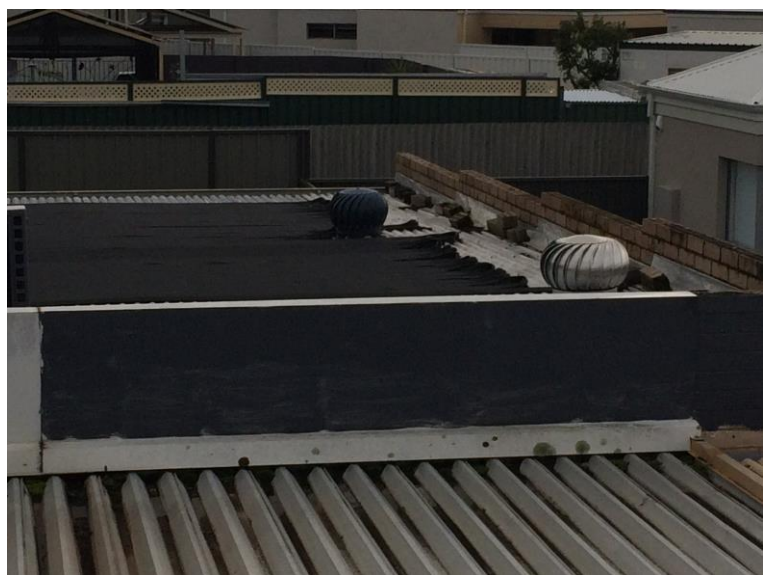
Flashing material and installation incorrect

5. The roof flashings: Poor, require replacement in areas
6. Roof tiles condition: Average, need cleaning, moss/lichen present

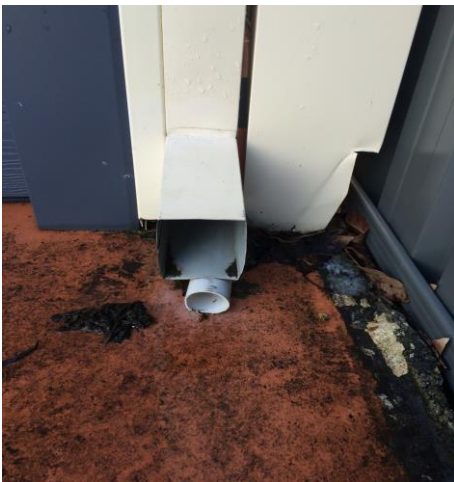
4. Site drainage: This site has inadequate surface inlet drainage. We recommend that additional site surface run off inlet and or diversion drainage be put into place around this property to protect this dwellings foundation materials. The stormwater drainage does not comply with AS 2870

Inadequate stormwater disposal

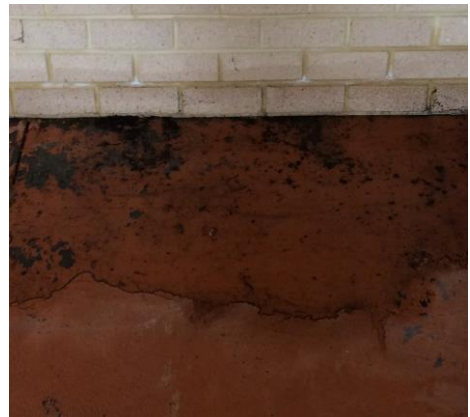
Inadequate drainage causing rising damp, rear garage

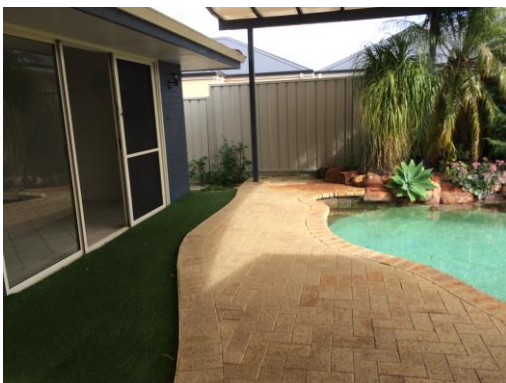
External site level higher than internal floor area, Inadequate drainage issues

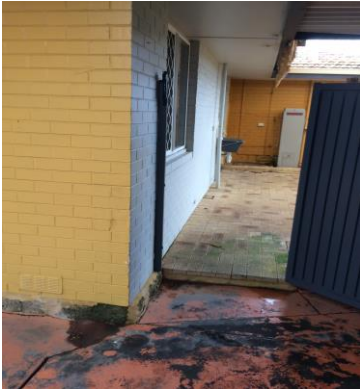
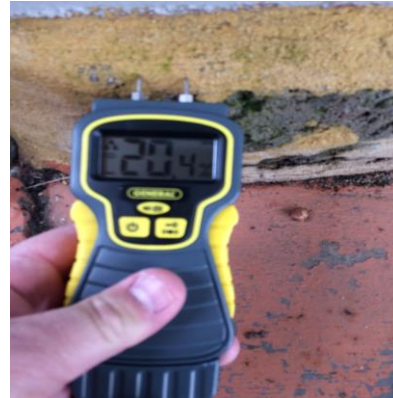
Inadequate drainage causing damp issues to buildings in areas

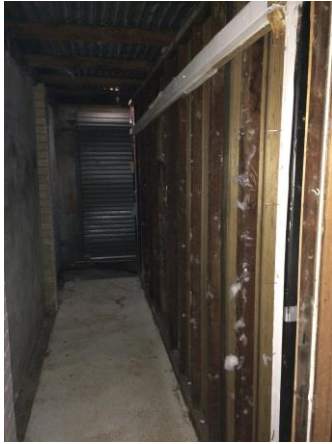
Further enquiries regard approvals for additions/renovations required

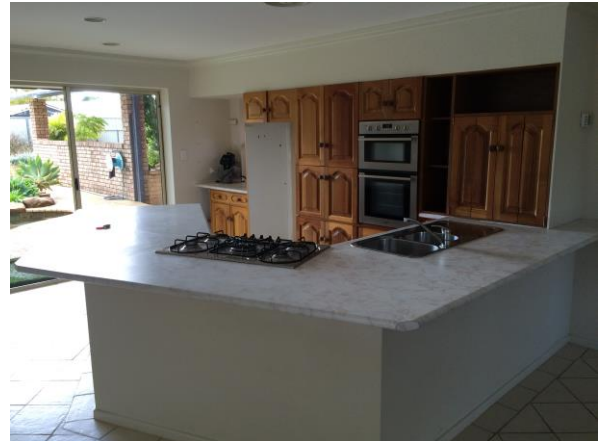
Kitchen generally Poor condition

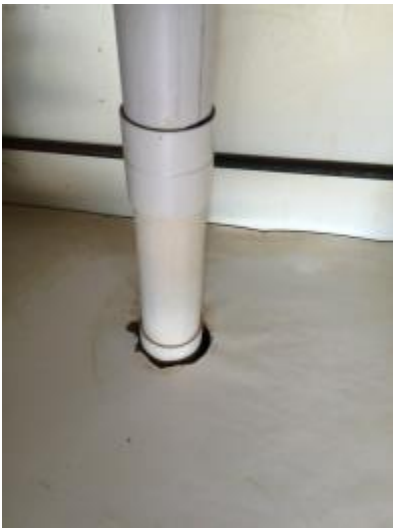
Evidence of leak to internal kitchen cupboards below sink

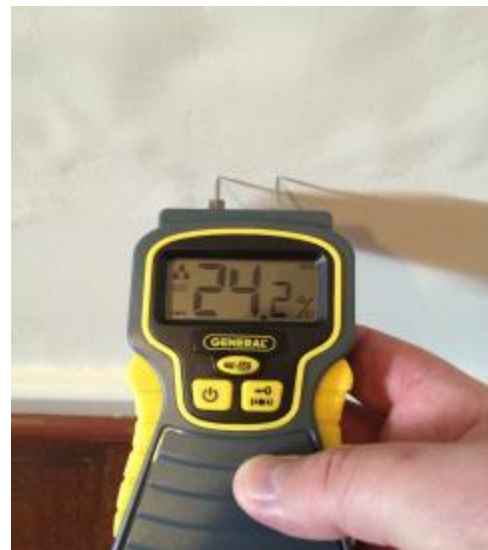
- 13/ Storage Gas hot water system is placed below ground level. There is a leaking pressure valve. 'D' & 'C'
- 14/ Evidence of rising damp needs to be investigated further 'C' & 'D'

Evidence of rising damp

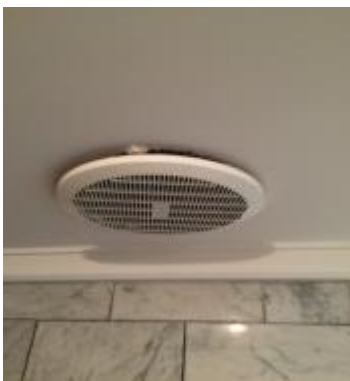
Safety Hazard: exhaust fan to bathroom needs to be reinstalled correctly
